# HOW ESTUARY RESTORATION IMPACTS SITKA SPRUCE

## WHY ARE SITKA SPRUCE DYING IN THE CARPENTER CREEK SALT MARSH?

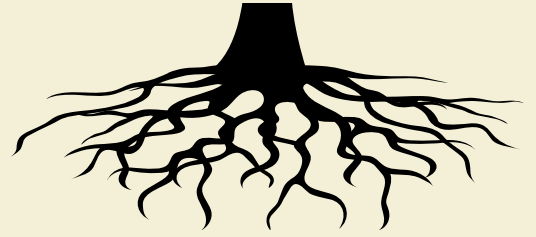
In many Sitka spruce, soil moisture was correlated with tree health. Healthier trees grew in drier soil, and less healthy trees grew in wet soil.

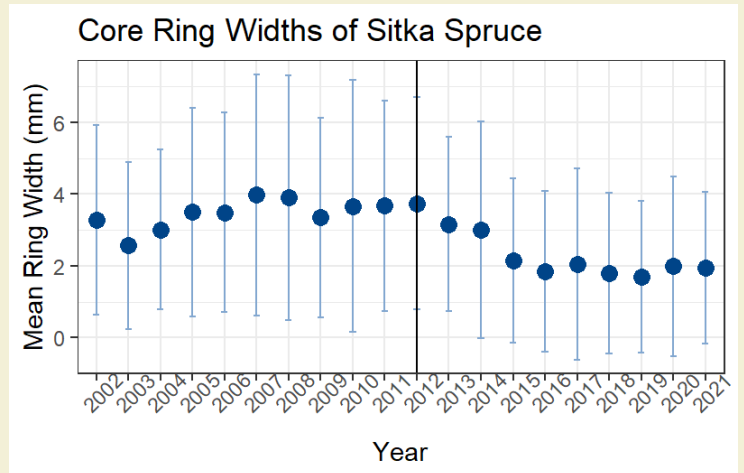
By measuring the width of tree rings we found out how much Sitka spruce grew each year.

Annual tree growth declined right after the first culvert removal, and hasn't recovered since.

Our data supports the hypothesis that removing the culvert in 2012 was directly related to the decline of Sitka spruce in the salt marsh. We think that when the marsh was opened up to the sea, increased water levels were too much for many of the trees.
